Finding New Bluetooth Low Energy Exploits via Reverse Engineering Multiple Vendors' Firmwares

Veronica Kovah
Dark Mentor LLC

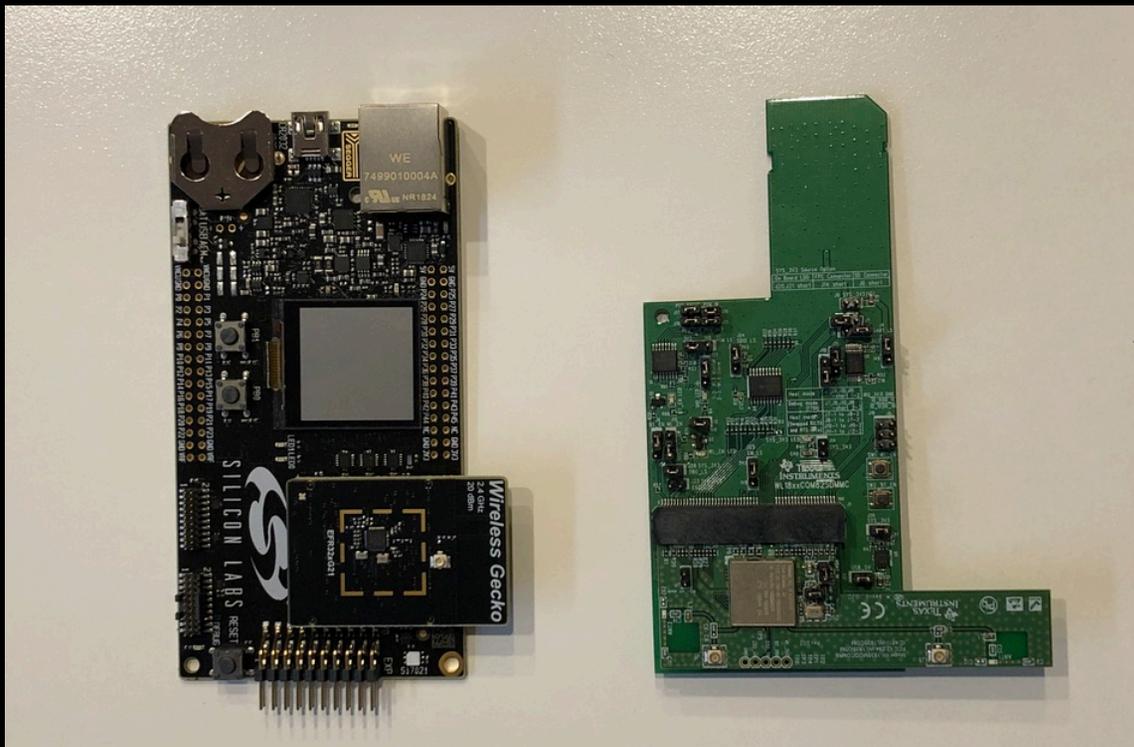
Lab setup: targets

My lab has way more development boards but these are the ones I will talk about today 😊

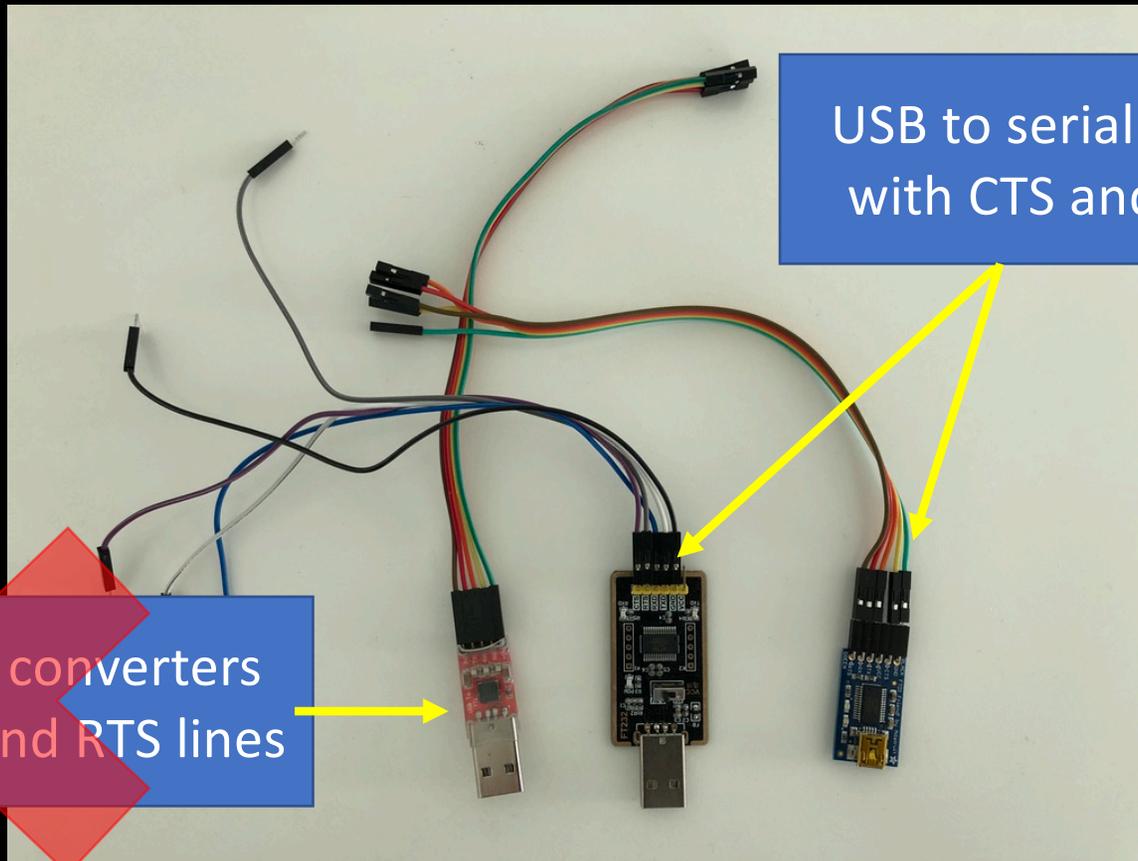
Lab setup: for basic HW debug 1

USB to serial converters
without CTS and RTS lines

USB to serial converters
with CTS and RTS lines

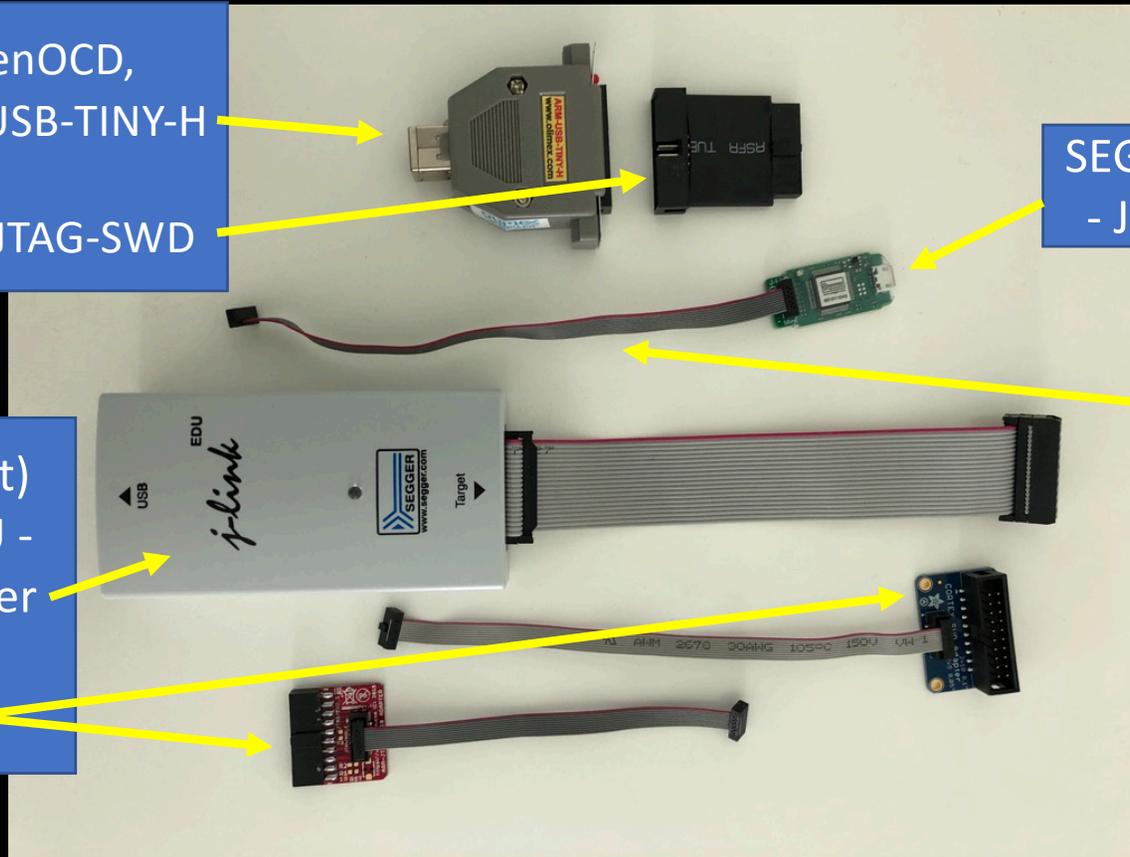
Lab setup: for basic HW debug 2

To use OpenOCD,
Olimex ARM-USB-TINY-H
+
Olimex ARM-JTAG-SWD

(used this the most)
SEGGER J-Link EDU -
JTAG/SWD debugger
+
SWD adapter

SEGGER J-Link EDU Mini
- JTAG/SWD debugger

10-pin 2x5 socket-
socket 1.27mm IDC
(SWD) cable

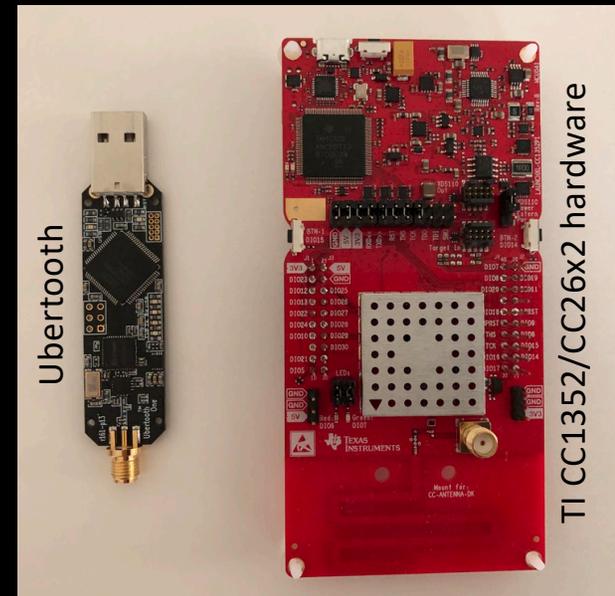
Lab setup: sniffers

- Ubertooth
 - Great Scott Gadgets hardware
 - Pretty console display
 - (SW) does not support extended advertisement packets
 - <http://ubertooth.sourceforge.net/>
- Sniffle
 - TI CC1352/CC26x2 hardware
 - Supports BT 5 packet formats / PHY modes
 - Was very useful to build/debug a BLE fuzzer
 - Less pretty console display for a demo
 - <https://www.nccgroup.com/us/our-research/sniffle-a-sniffer-for-bluetooth-5/>

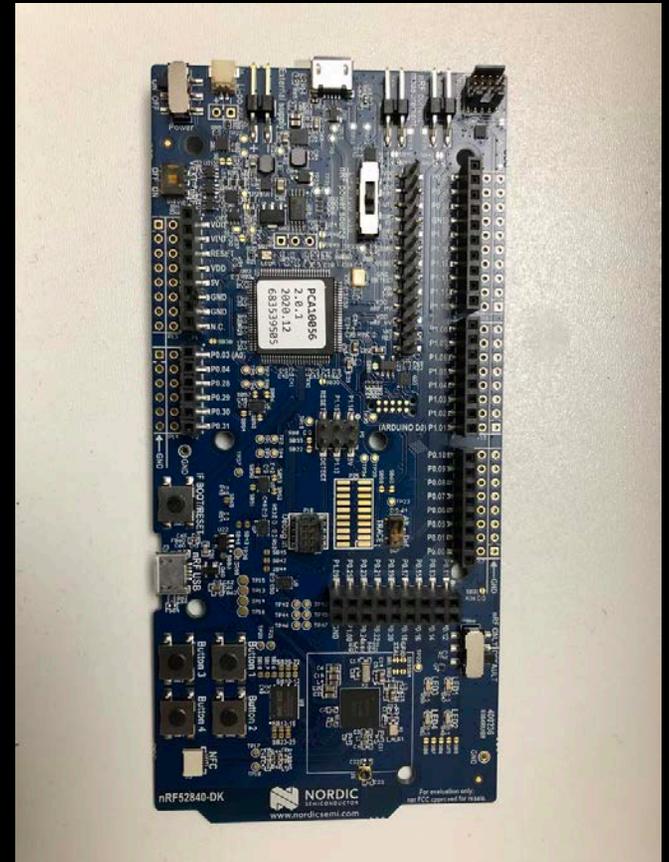
Lab setup: packet sending HW

- Started with Nordic Semiconductor nRF52832 dev board
 - Selected this first because open source BLE implementations had more documentation with this board (obviously B/C it's older dev board!)
 - USB to serial converter is necessary
- Ended up with nRF52840 dev board
 - UART interface through a virtual COM port
 - No USB to serial converter is needed

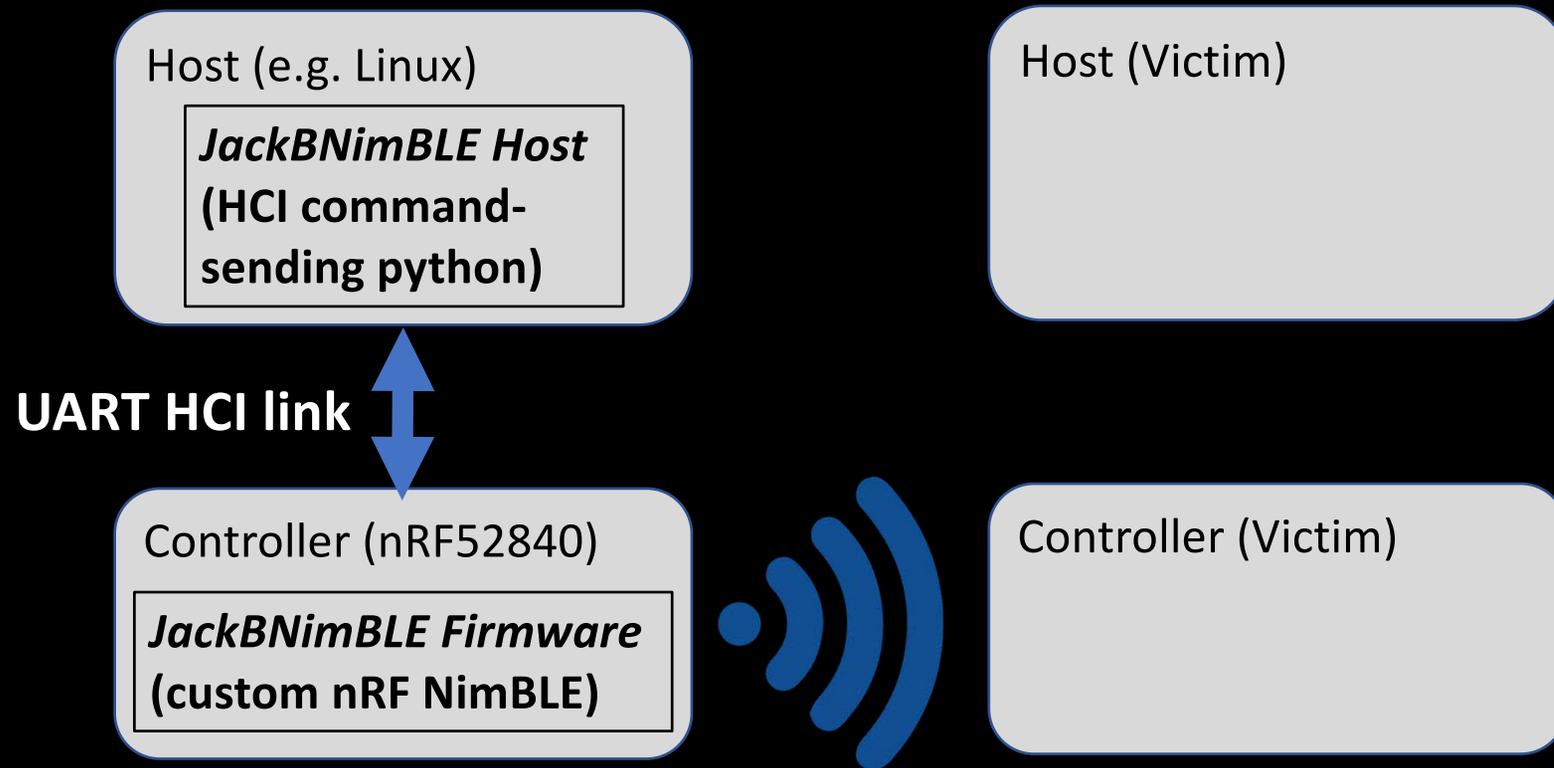
Lab setup: JackBNimBLE, packet sending SW

- Send arbitrary BLE Link Layer packets
- Extracted from my home-made fuzzer
- Controller SW: made modification to Apache Mynewt NimBLE (<https://mynewt.apache.org/>)
- Host SW: python scripts via HCI interface
- Current version can be used to share PoC
- Easy to extend, e.g. fuzzer
- <https://github.com/darkmentorllc/jackbnimble>

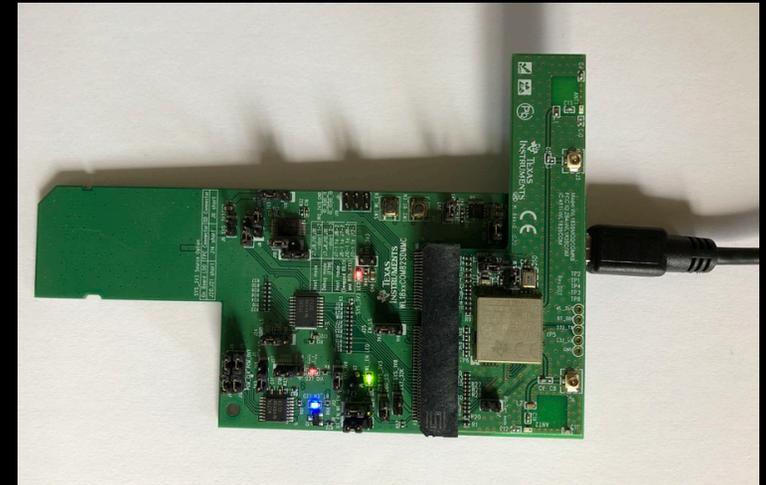
Target #1: Texas Instruments WL1835MOD

- Bluetooth v4.2
- Dual mode (BT classic and BLE)
- No JTAG or SWD readily available
- BLE Link Layer is in ROM
 - Host applies a patch
- No firmware image readily available
- WiLink™ Wireless Tools for WL18XX modules
 - HCITester: .bts binary patch -> human-readable format
 - Logger: UART binary debug messages-> human-readable format
