# Debug Resurrection on nRF52 Series

BlackHat Europe 2020

- Context
  - 2 months (Lockdown)
- Main Objective
  - Find a way to break the APPROTECT on nRF52840
- How to do that?
  - I don't know yet...

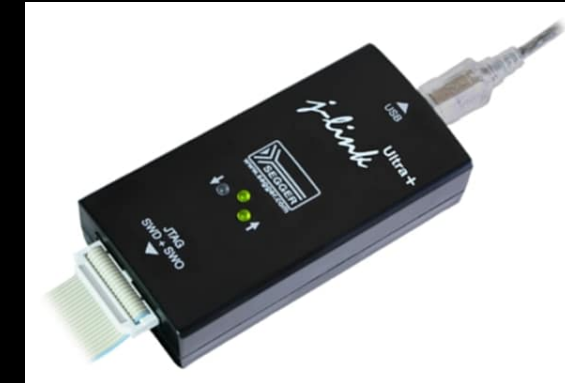
- 50 Euros :\
  - Download the SDK (nRF5\_SDK\_16.0.0)
  - Install Nrfjprog (v10.6.0)
  - Embedded Segger J-Link debugger
    - Based on a MicroChip ATSAM3U2C (white sticker)
  - Install debugger driver JLink (v6.64)
  - Can be used independently :)

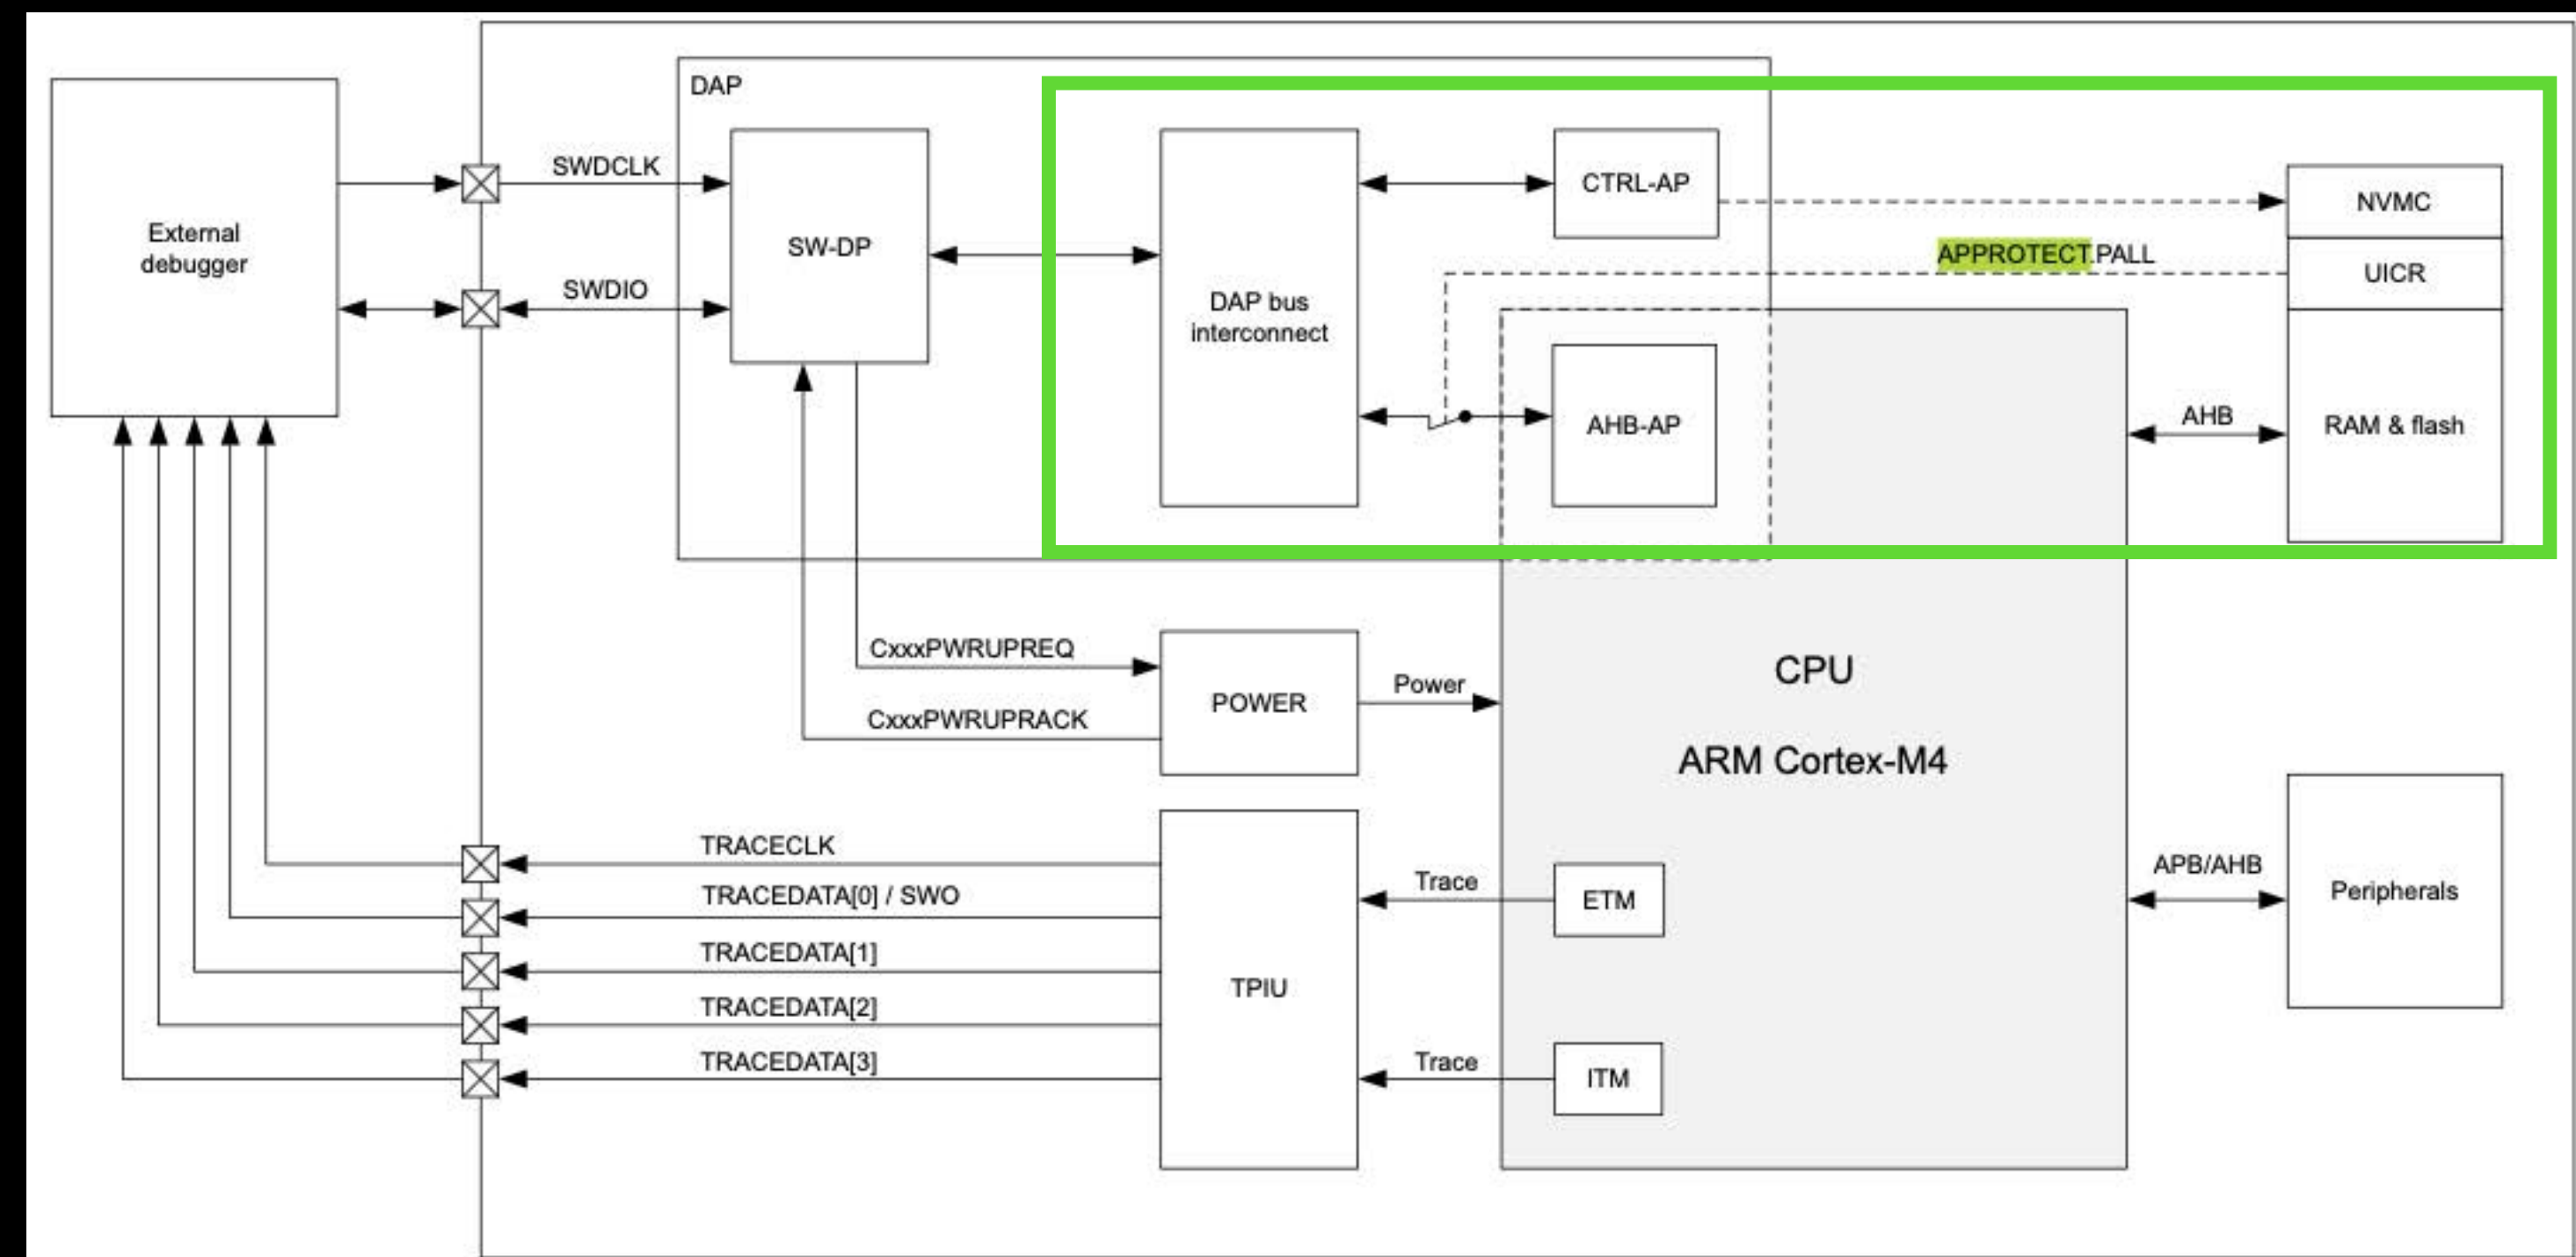
- Accessing ARM CPU through the Debug Access Port (DAP)
  - CTRL-AP
    - Master Debug Port
    - Not dependent of the APPROTECT
  - AHB-AP
    - Access Memories and Control the CPU via SWD
    - This is the “Real” Debug Port
- ARM Cortex-M reference pretty useful here

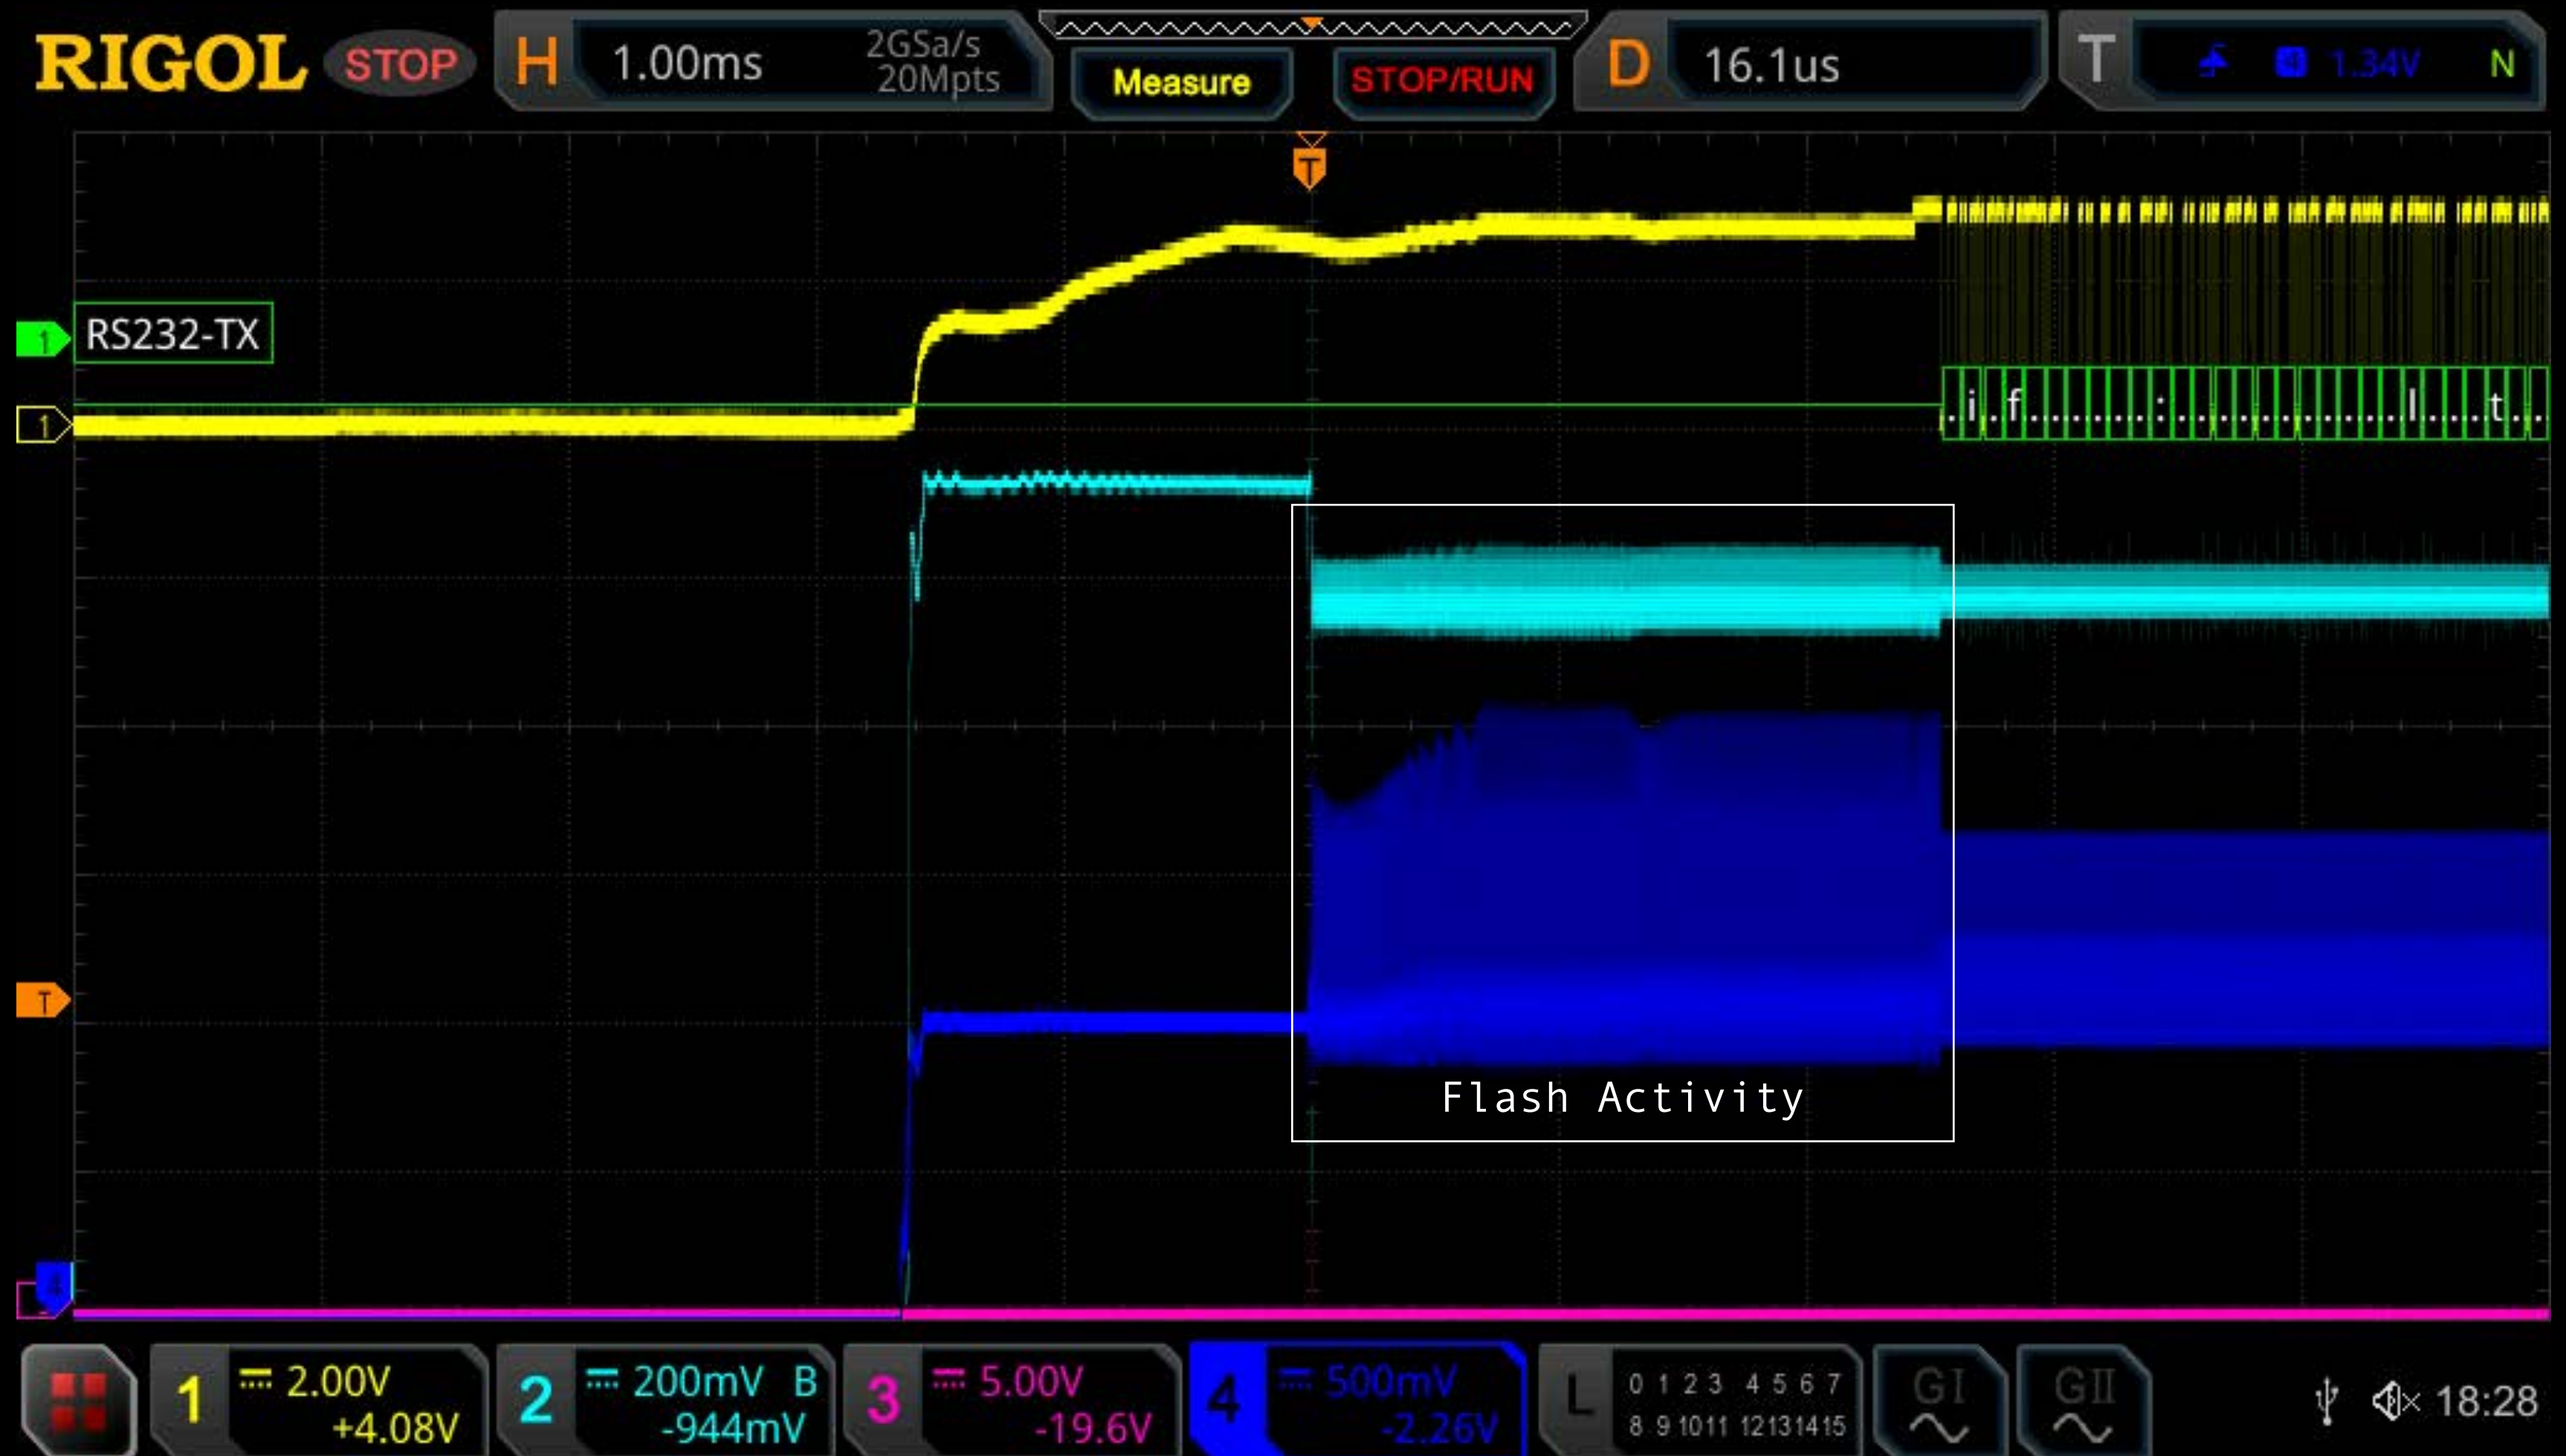
- CH1 = TxD (pin P0.06)
- CH2 = Power consumption through DEC1
- CH3 = Pulse command to trig the Glitch
- CH4 = Power consumption through DEC4 (Scope Trigger)

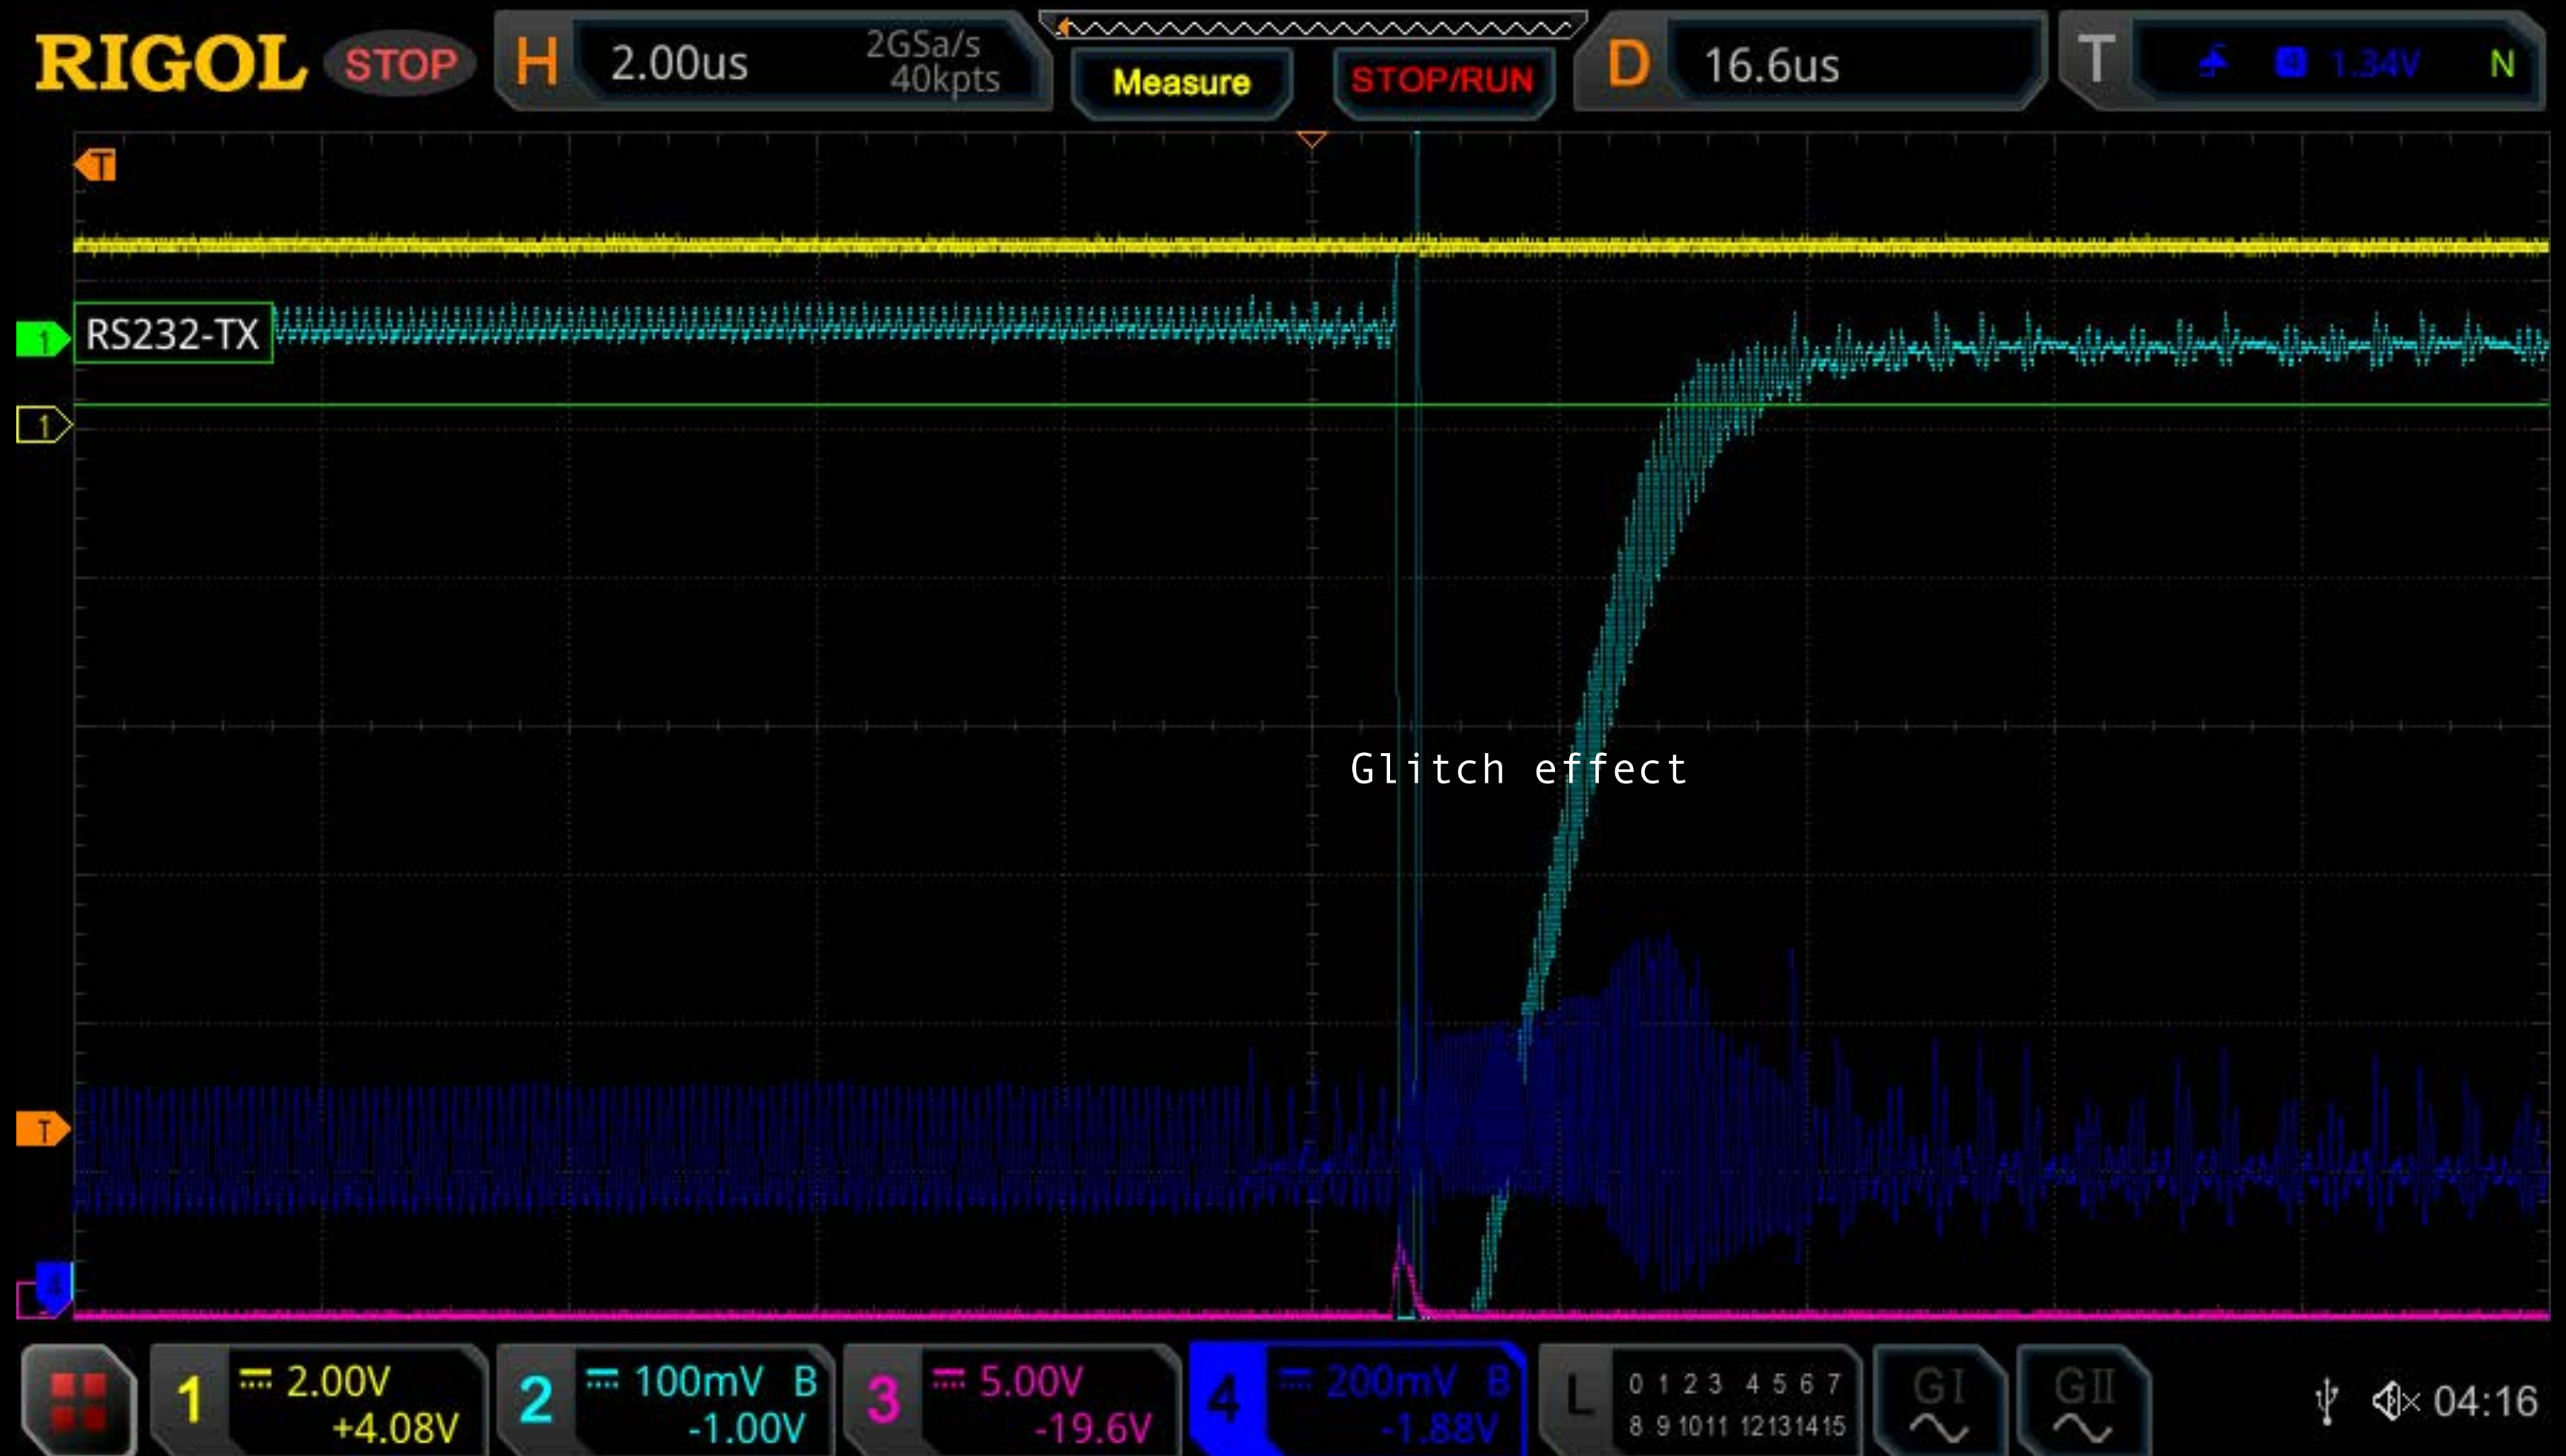
- Successful glitch
- Differences on both Power Lines
- No Flash Activity after

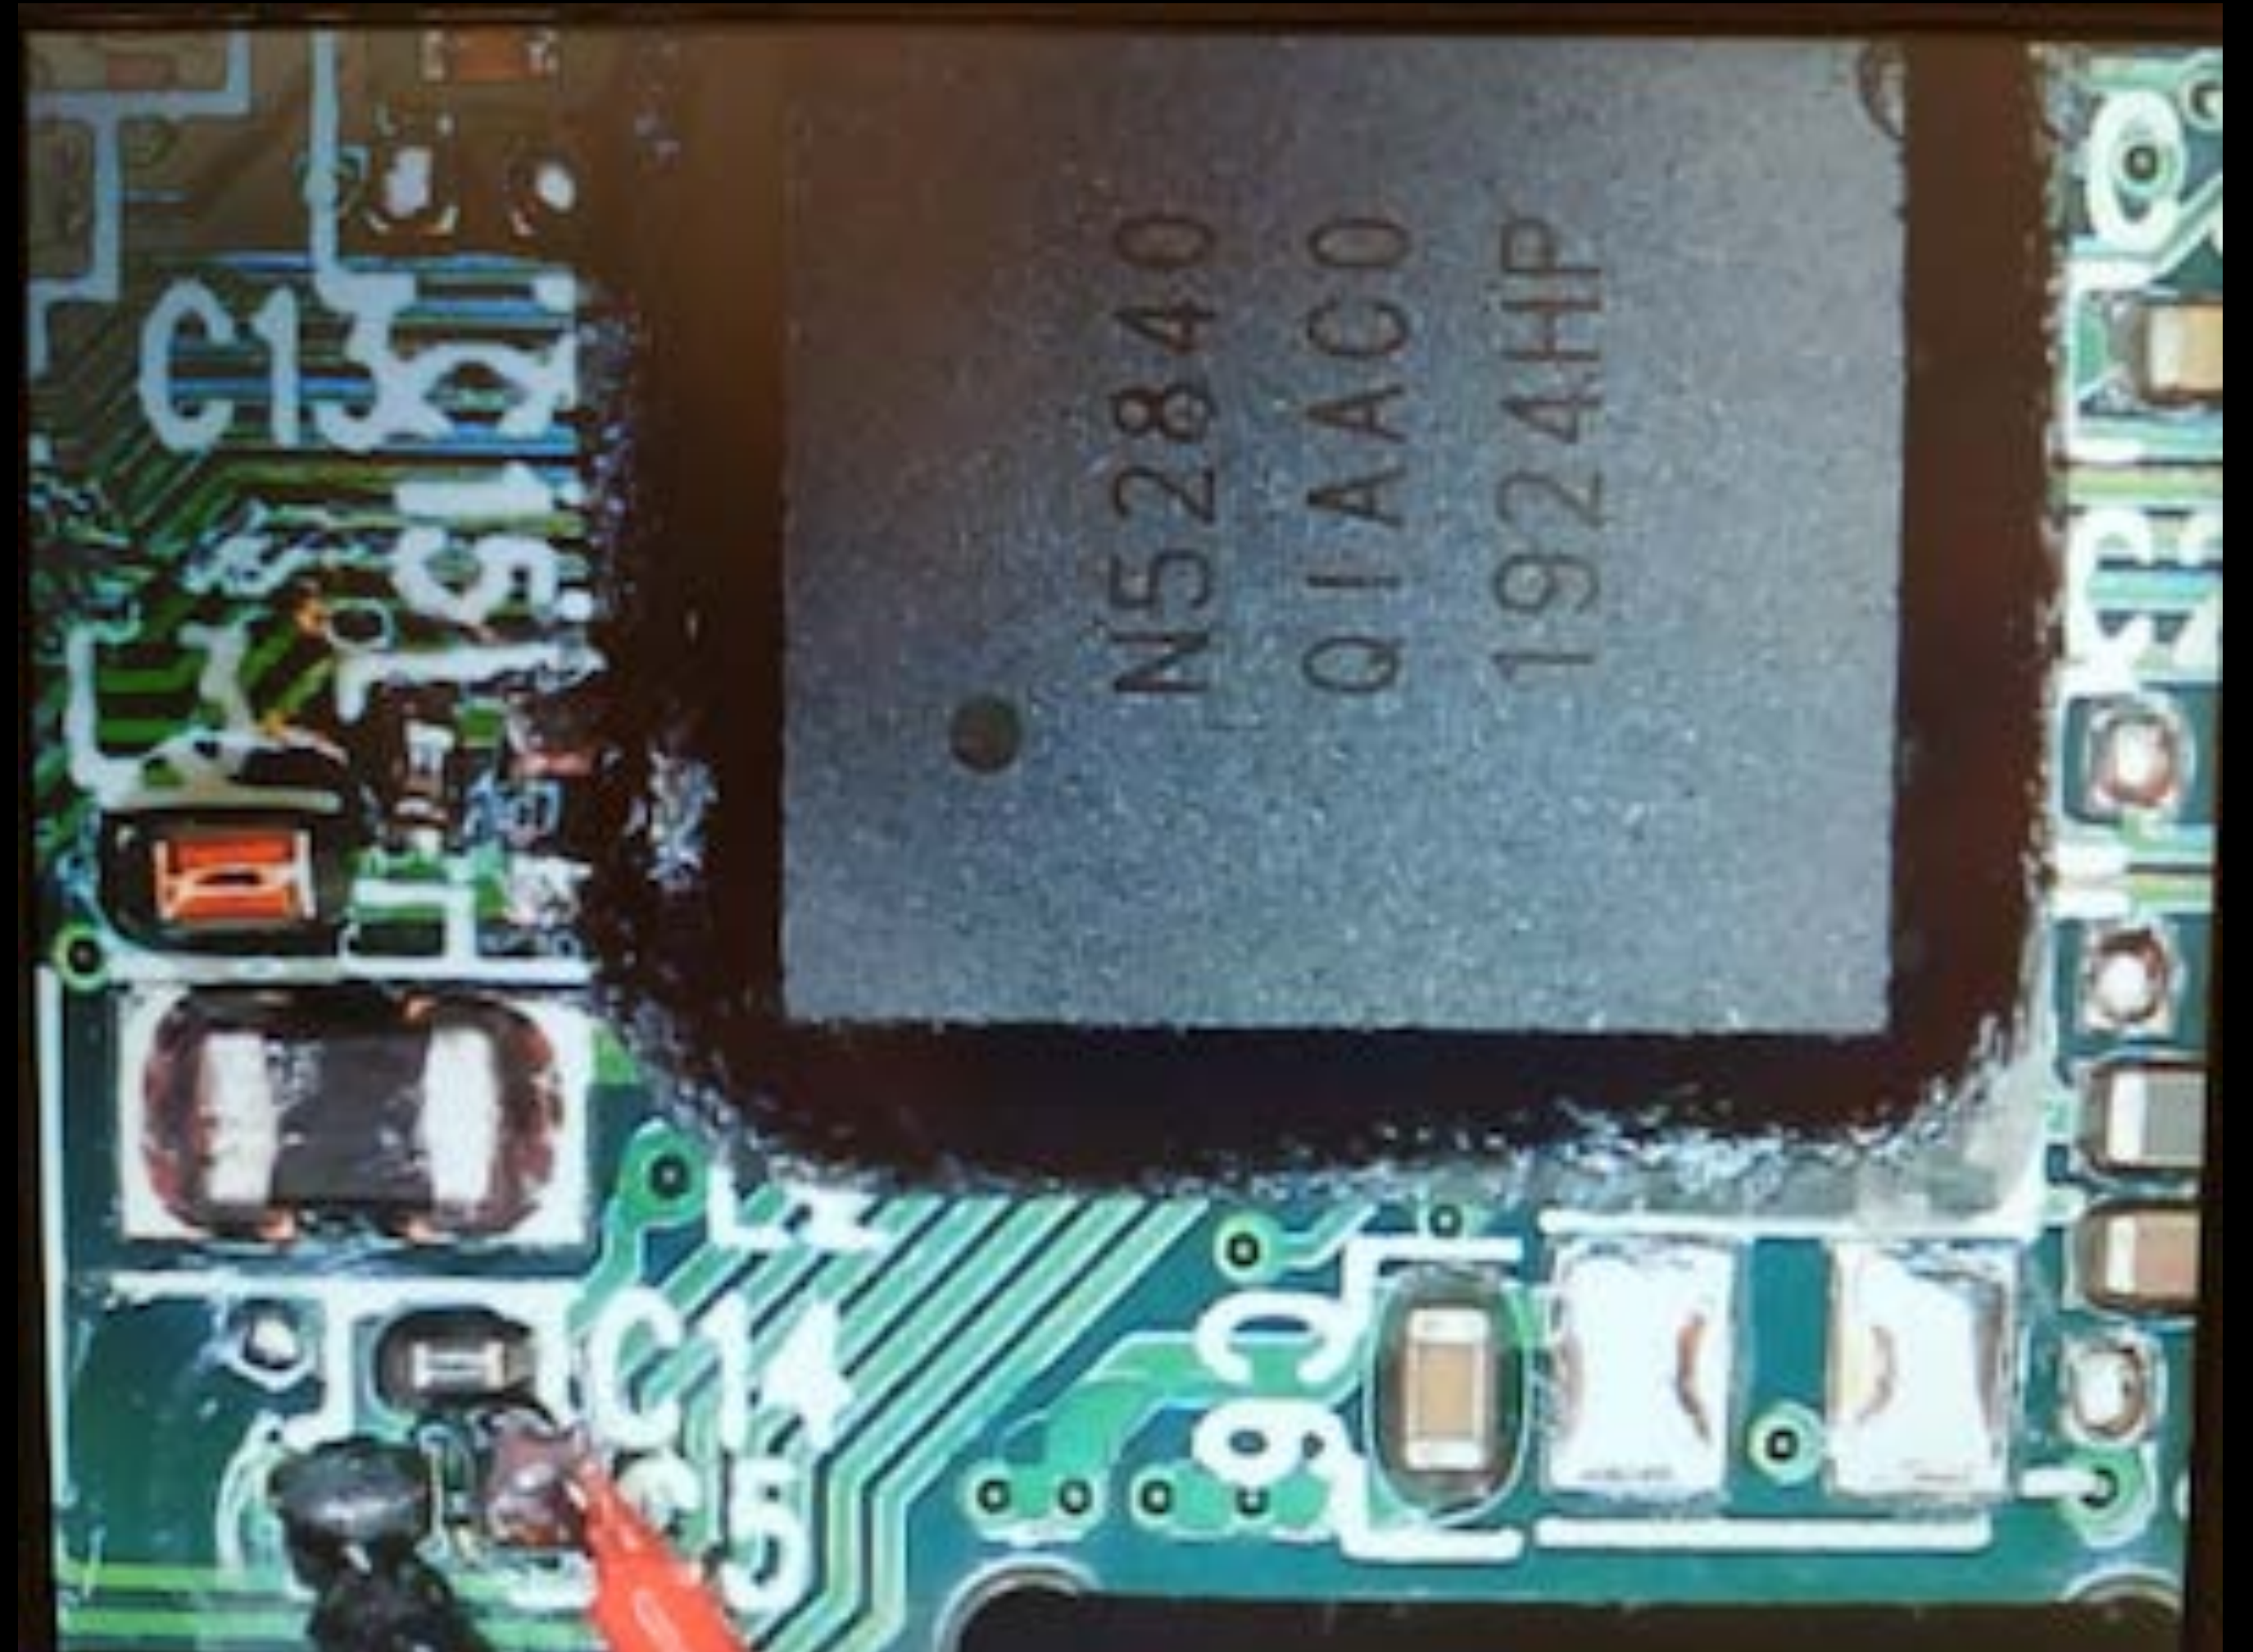
- PCB Reference design
  - provided by Nordic
  - Reused by Logitech
  - Silkscreen
- No need to reverse PCB
  - Easy job

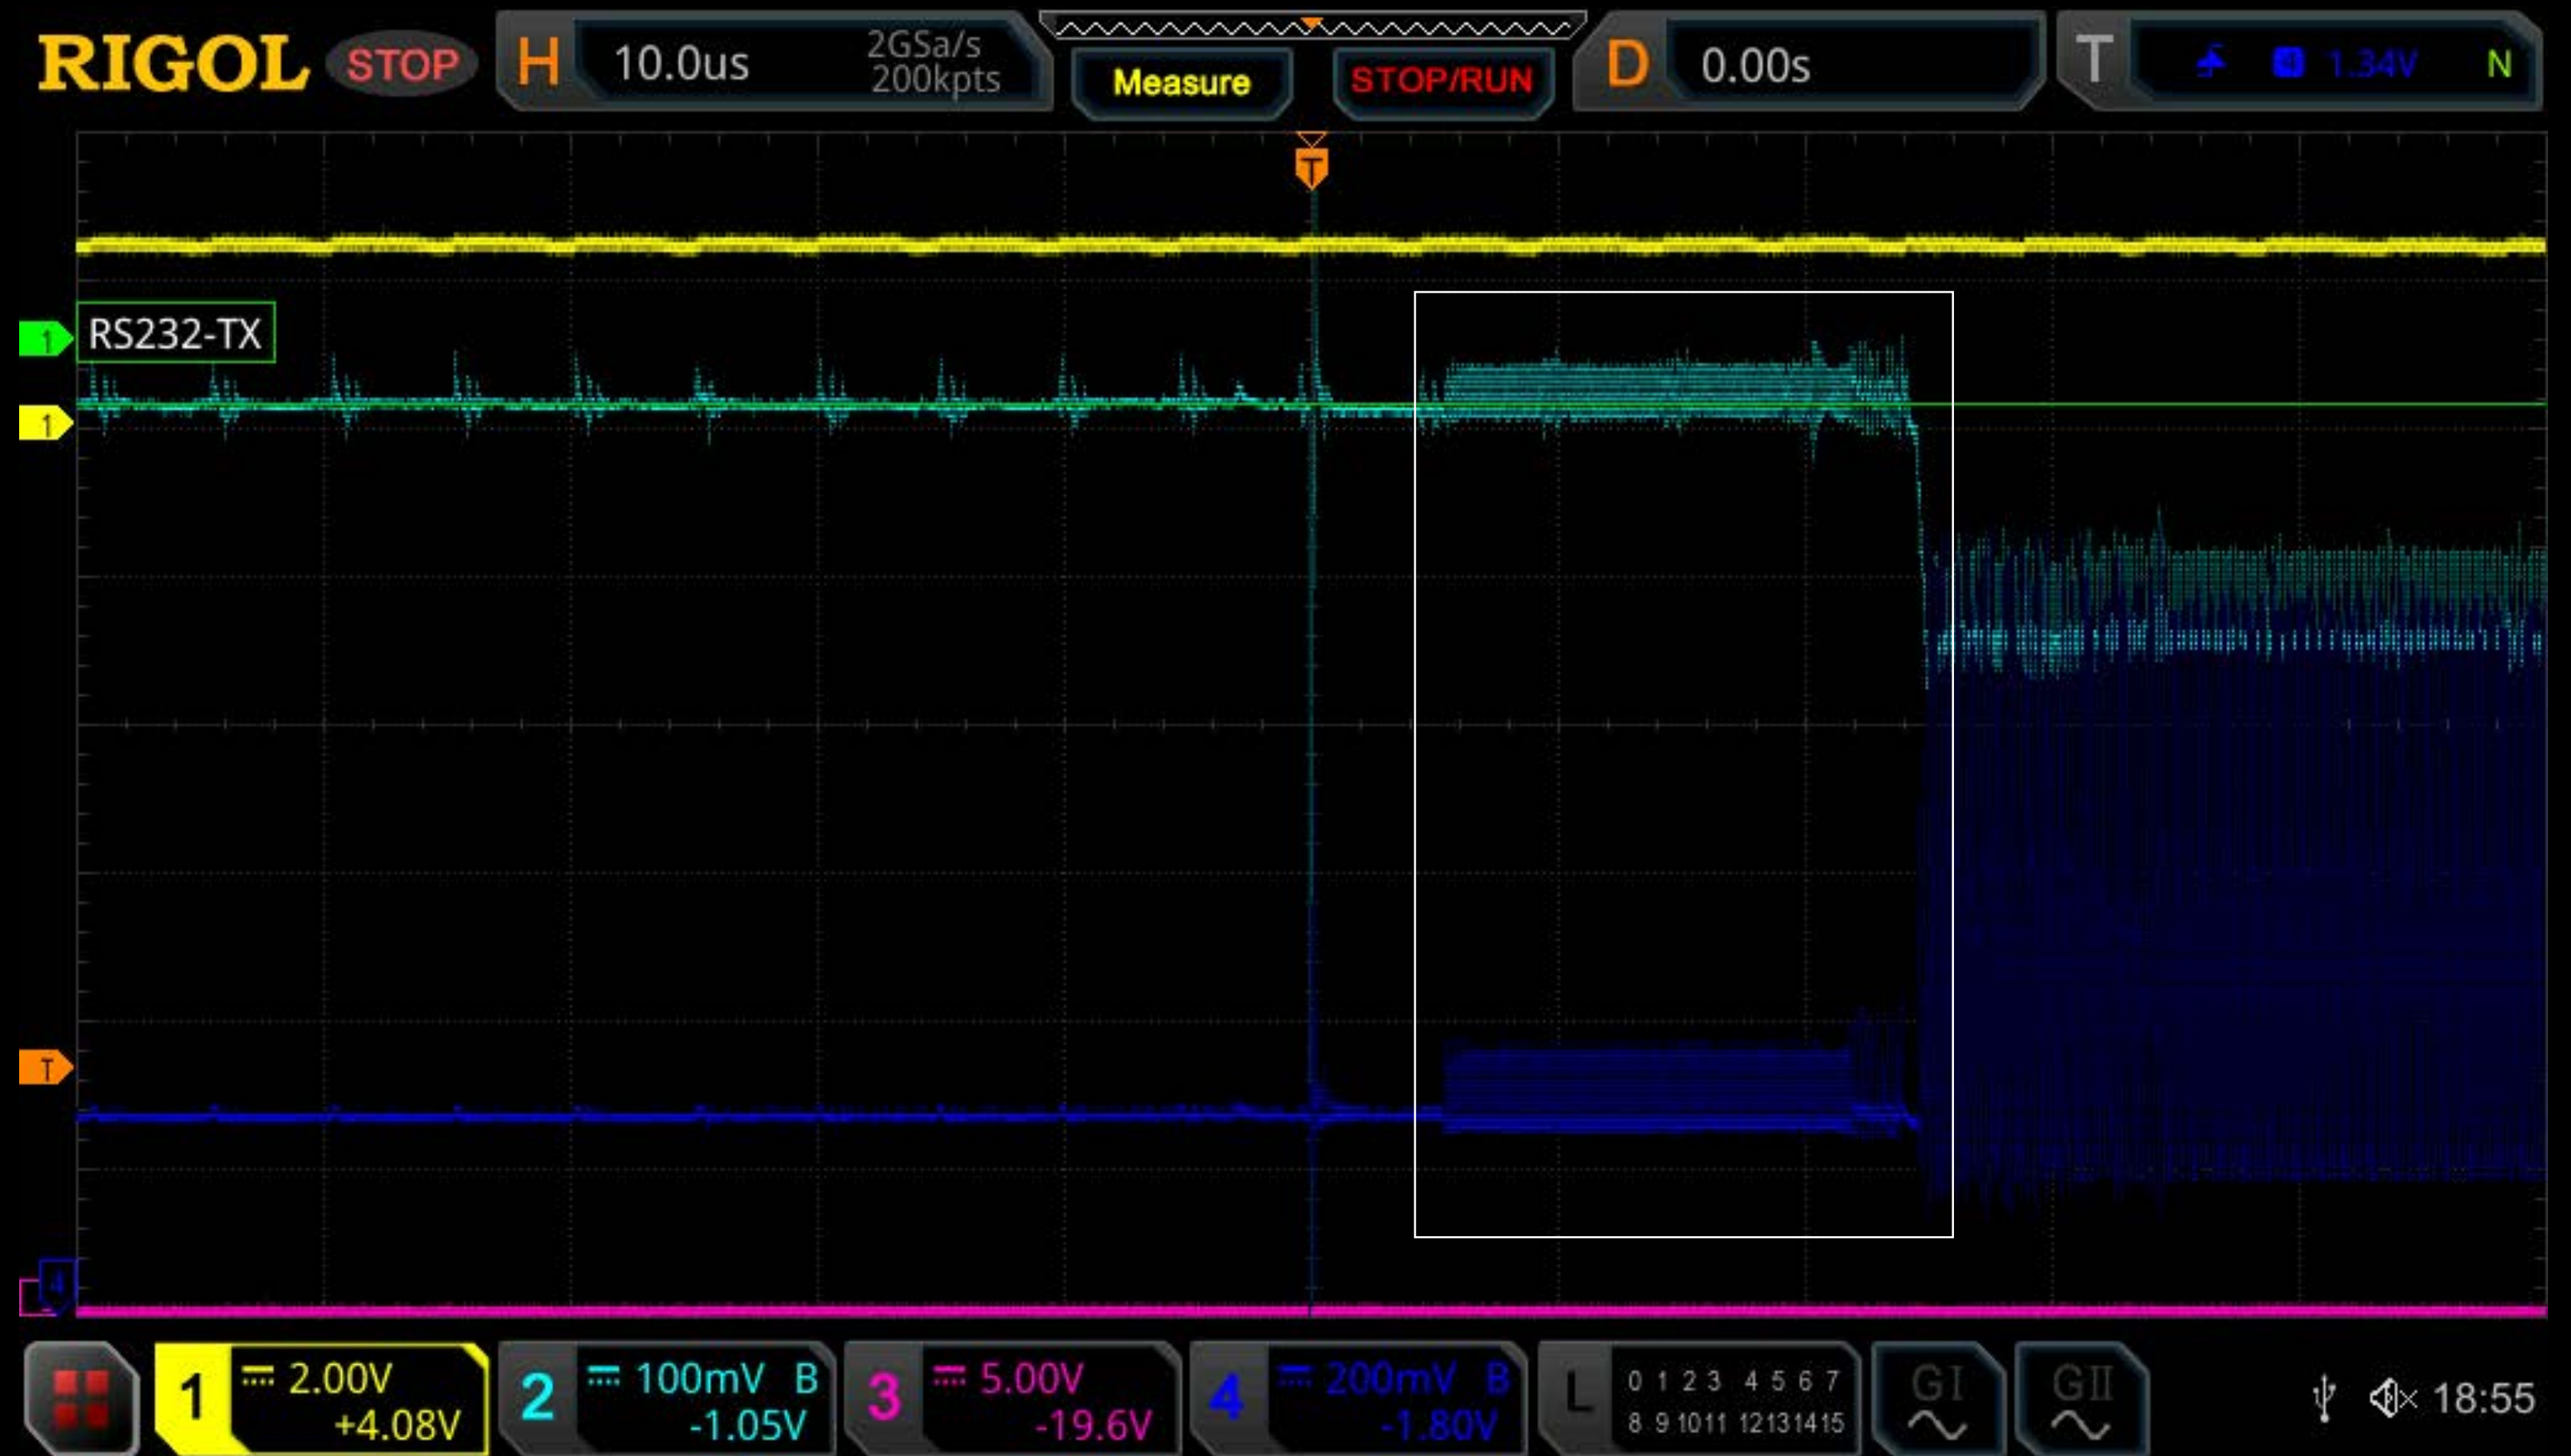
- Clean Power Consumption on DEC1 (CPU)
- Clean Power Consumption on DEC4 (global)

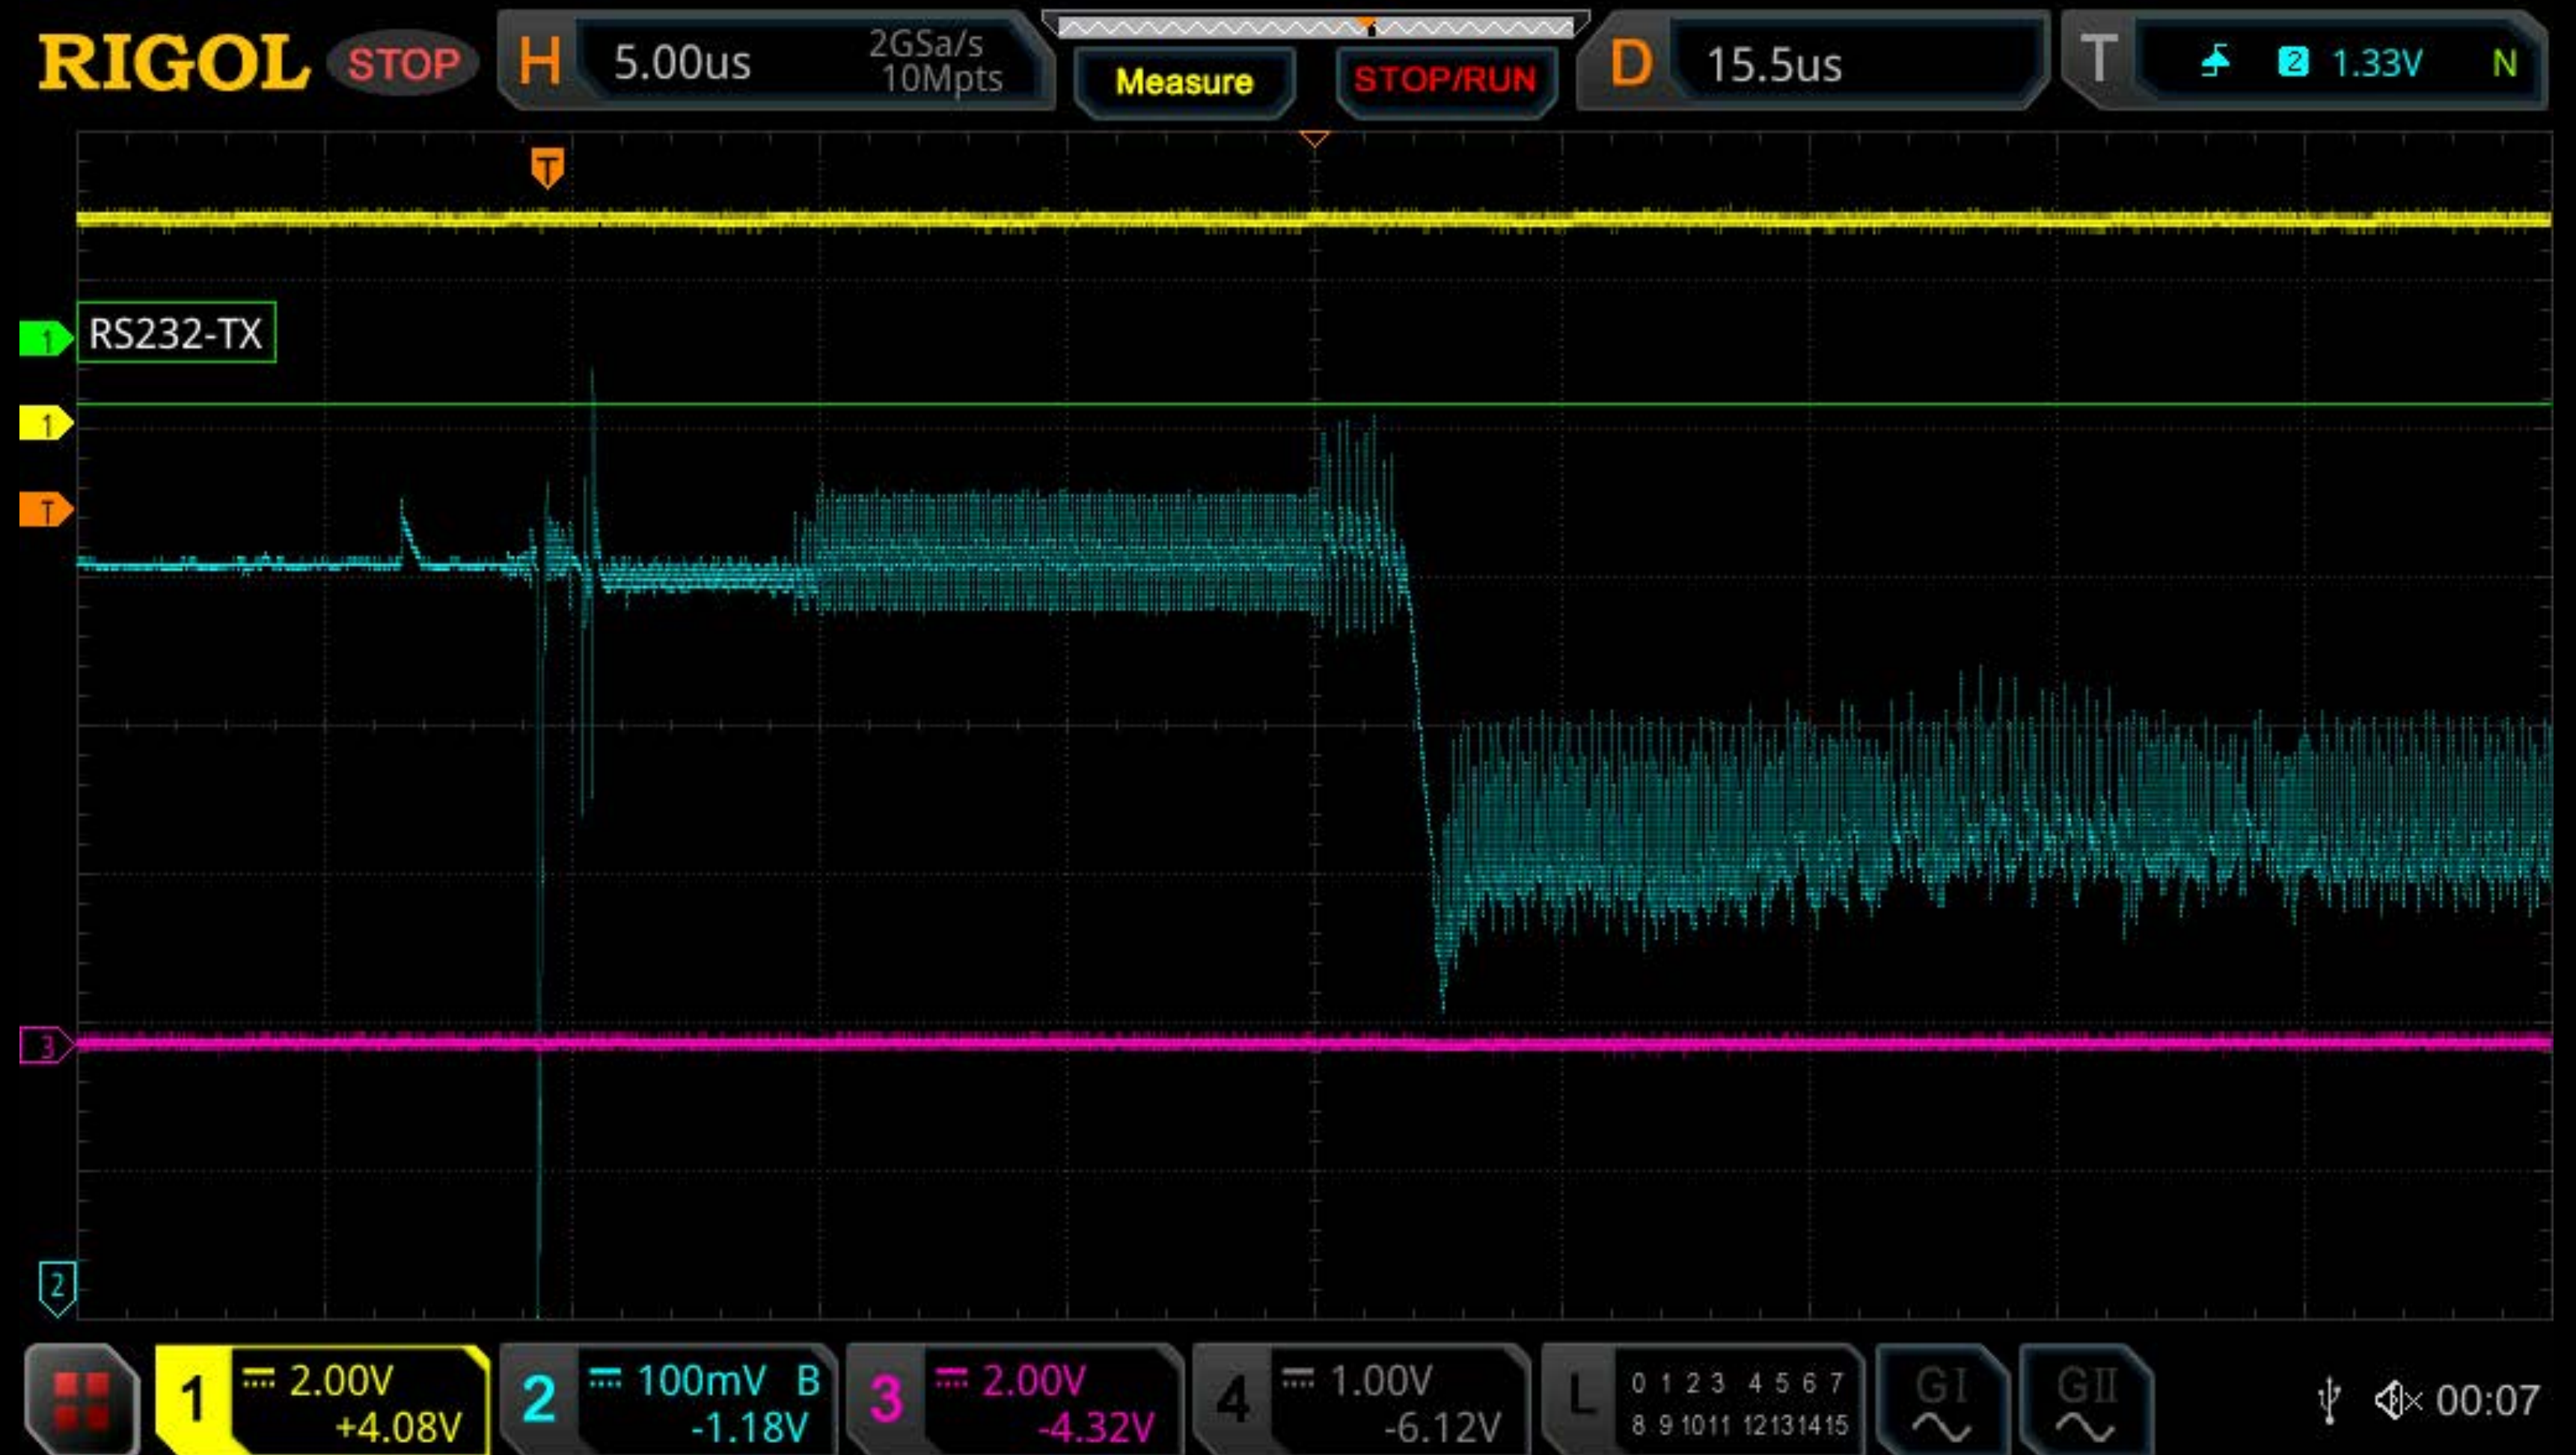
- Clean Power Consumption on DEC1 (CPU)
- The same pattern can be easily identified
